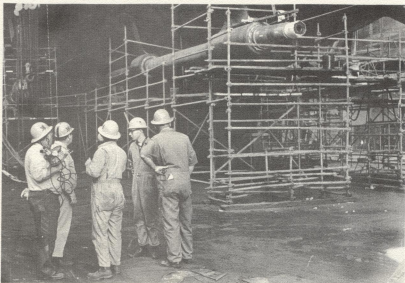
Above--Runout tests confirmed the part inboard shaft was bent. Yardworkers in foreground discuss its removal.
